INVESTIGATION OF MICROSTRUCTURAL AND MECHANICAL PROPERTIES OF CARBURIZED GENERAL CONSTRUCTION STEEL

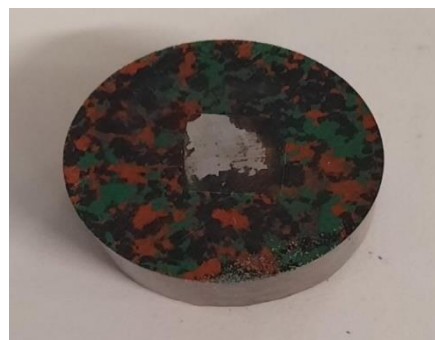
Hot Coating. Bakelite coating was applied to 6 different specimens that had undergone cementation at 180 °C for 5 minutes. These processes were carried out in the CitoPress – 10 hot molding device. The purpose of this application is to enable the sample to be examined more efficiently under the microscope. Another purpose is to better hold the part in the sanding and polishing application.

Fig. 1. Bakelite coated specimen

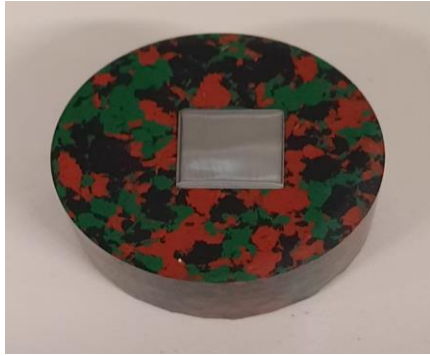
Sanding and Polishing. Some deformations may have occurred on the surface of the sample after the cutting and cementation process. In order to eliminate these problems and to reveal the original internal structure, the hot-coated sample is processed in an automatic sanding and polishing device called tegramin – 30. Figure 2 shows the treated sample [4].

Fig. 2. Sample with sanding and polishing processes

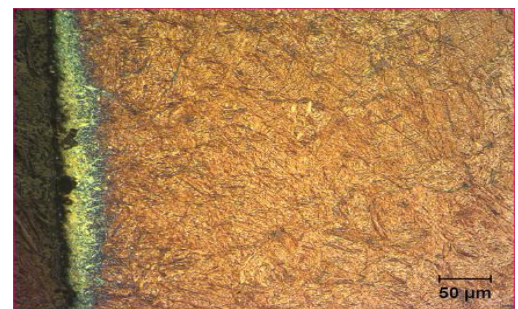
Fig. 11. Sample treated at 930 °C for 3 hours ×200

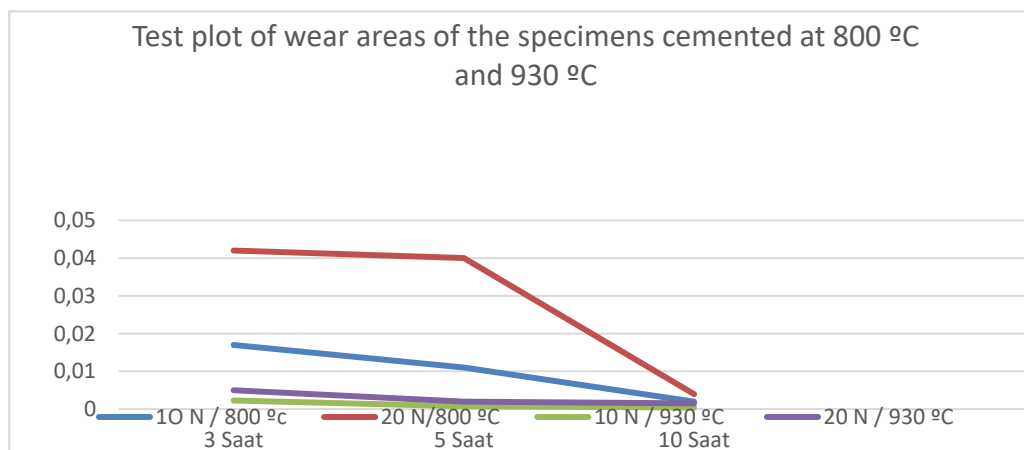
Fig. 17. Change of wear areas depending on parameters

As a result of the abrasion test of 6 different specimens cemented at 800 and 930 °C, the areas of the worn areas are given in Table 3. Accordingly, if the load applied to the samples increases while the temperature is the same, the amount of wear increases in direct proportion. As the hardness values of the samples increased with the increase of

cementation time, the wear areas on the surface decreased. As can be seen in the figure, the most exposed sample is the material that has been cemented for 3 hours at 800 °C with a load of 20 N. Since the applied force load is

increased and the cementation time is short, the wear is at the highest level in this sample.

The wear loss of the material at 930 °C, where the applied weight is 10 N and cemented for 10 hours, is at the lowest level compared to other samples.
